Tucumcari Neon Restoration Project Update - November 19, 2023:

Phase One of the Tucumcari Neon Restoration is nearly completed!

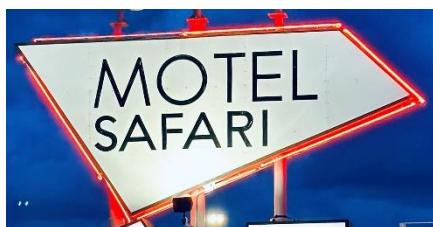
Motel Safari is fully back up and glowing once again!

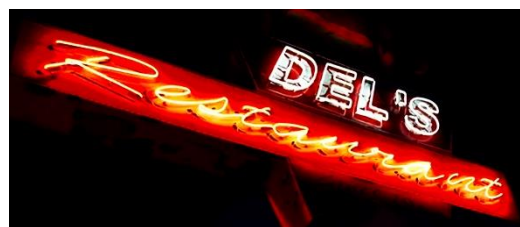
Del's Restaurant is fully back up and glowing once again!

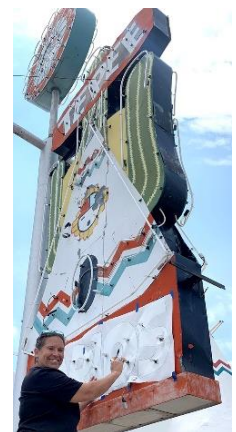
Tee Pee Curios was full of water when we first inspected it back in August. We drained it, removed and made patterns of the broken neon pieces, and replaced broken hardware on the outside while the inside was drying. On our return trip in September, Paul Greenstein, a neon expert, joined us from Los Angeles. The new neon pieces were installed and Paul gave the sign a thorough inspection. It was apparent the transformers were about to give out as well as wiring needed to be replaced. Unfortunately, this 3-day restoration trip was cut short by a whole day due to unexpectedly being without the bucket truck for a day. Therefore, we were unable to replace any wiring at that time. Two transformers were ordered, and plans were to replace them and the wiring on the next restoration trip. Rather than wait for our next trip to have these items taken care of, the owner of Tee Pee Curios chose to complete the project with other volunteers.
